Cananea Copper Mine

An International Effort to Improve Hazardous Working Conditions in Mexico

INT J OCCUP ENVIRON HEALTH 2009;15:14-20

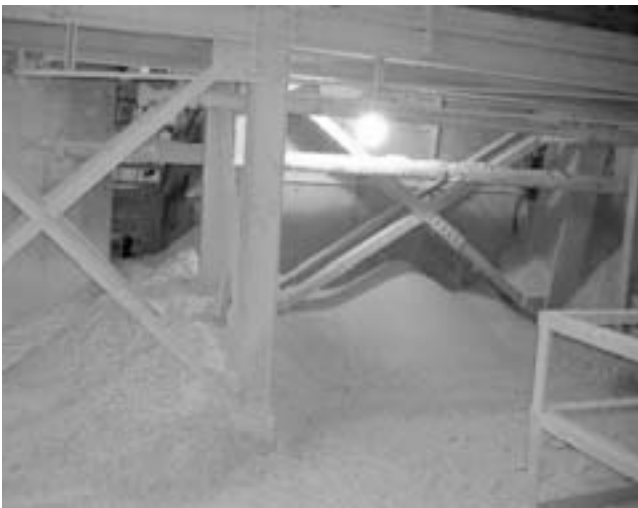
During the site walk through, the OHS team also observed reduced visibility due to rock dust clouds created by simply walking through work areas in the Concentrator Department buildings. We observed that large piles of settled dust that had accumulated throughout the plants, including blocking stairwells and passageways (see Figure 5).

Figure 5—Piles of settled rock dust blocked passages and emergency exits in the multi-building Concentrator department.

1. When the mine reopens, a massive clean-up operation will be required to eliminate the most immediate hazards to workers' health and safety, including repair of malfunctioning equipment, installation of adequate guards on moving machine parts and energized electrical circuits and panels, and a thorough housekeeping of the facilities.

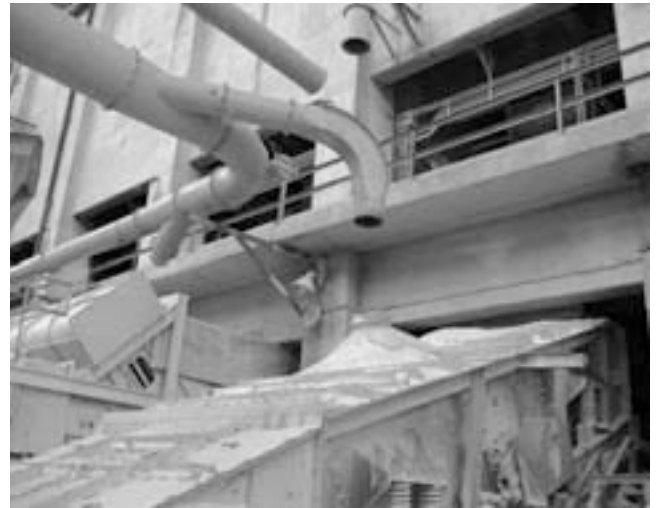
Workers reported exposures to dense clouds of rock dust due to the fact that dust collectors were dismantled by Grupo Mexico, and the ductwork laid out on the ground outside the plants, nearly two years prior to the strike. Workers described visible dust constantly suspended in the building air when machines were operating or when workers disturbed deposited dust by walking through various mine areas. Workers reported that visibility inside the plants, when operating, was limited because of the dense clouds of airborne dust.

Figure 6—Disassembled ventilation systems in the Concentrator plants created worker exposures to airborne silica inside the buildings at levels at least 10 times the Mexican regulatory limit.

fatal respiratory diseases including silicosis and lung cancer.¹² At the estimated concentrations, and absent engineering controls to reduce dust levels, workers in the concentrator areas must be provided with powered air-purifying respirators (PAPRs), or supplied-air respirators operated in continuous flow mode. Grupo Mexico has provided only paper filtering face piece respirators. In addition, medical evaluation, fit testing, and training have not been provided to respirator users. Instead of installing engineering controls to eliminate or reduce exposure to airborne chemical hazards, the company has provided personal protective equipment (specifically N-95 respirators) only in the ESDE plant.

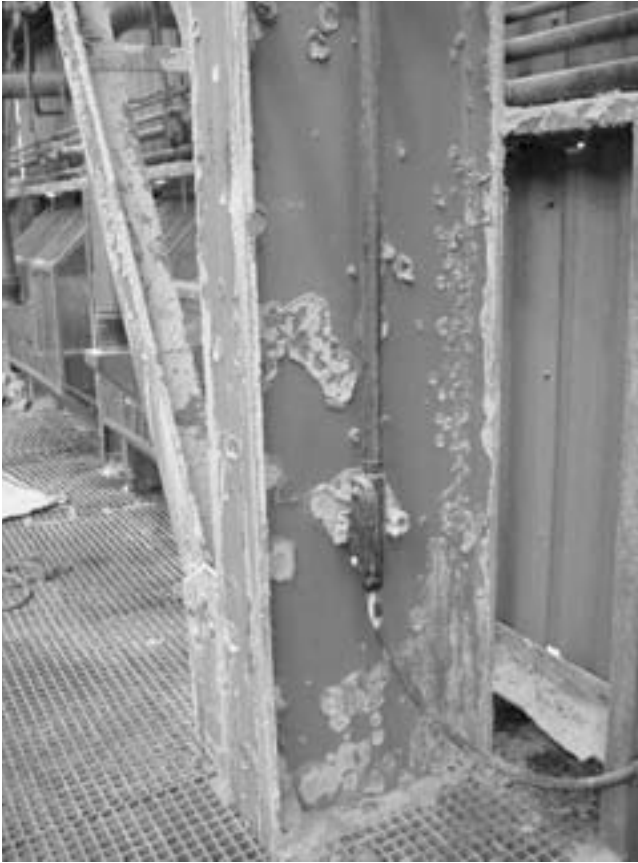
In addition, lack of adequate ventilation and engineering controls in the ESDE plant has meant that the acid mist inside the plant has literally eaten away the concrete floor and structural steel beams holding up the roof, presenting serious respiratory hazard for workers (see Figure 7).

Figure 7—Lack of effective ventilation in the ESDE #2 building resulted in high levels of sulfuric acid mists which corrode structural steel beams supporting the roof.
