Fatality Assessment and Control Evaluation (FACE) Program

A Machine Operator Died When Caught in the Threads Being Wound onto the Take-up Spool of a Warping Machine

California Case Report: 06CA006

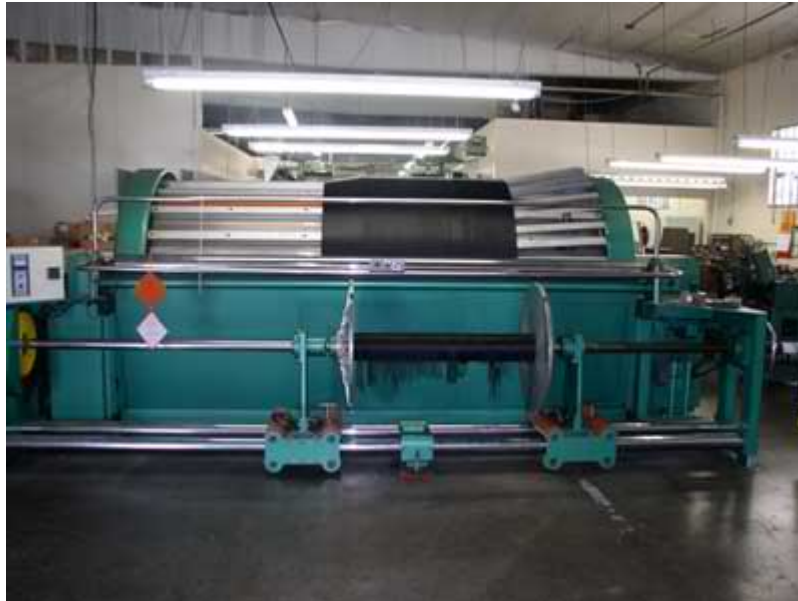
Exhibit 1. A picture of the machine involved in the incident.

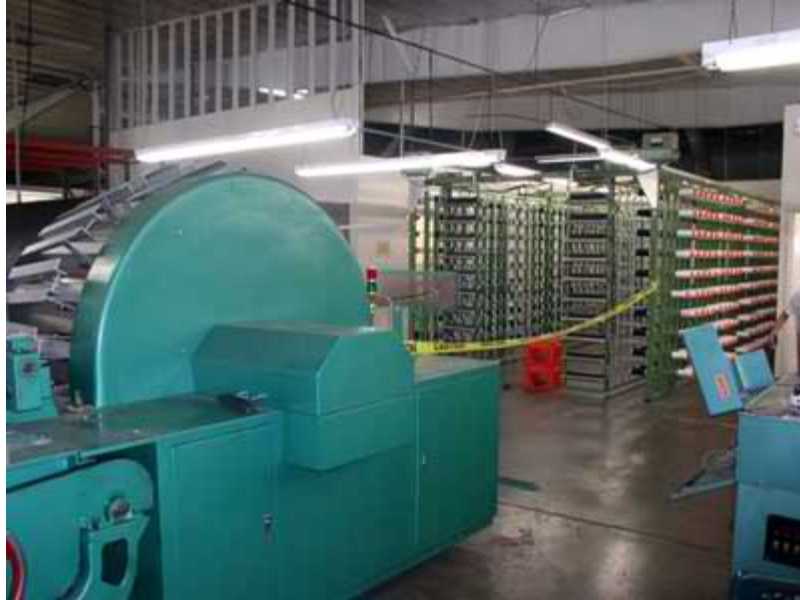
Exhibit 2. A picture of the left side of the machine showing individual spools of thread on racks being fed into it.

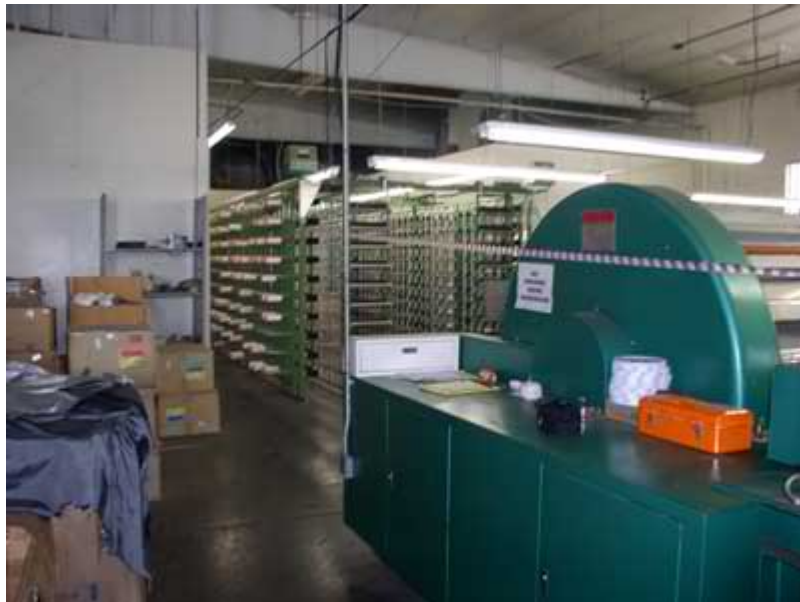
Exhibit 3. A picture of the right side of the machine showing the individual spools of thread on racks that are being fed into it.

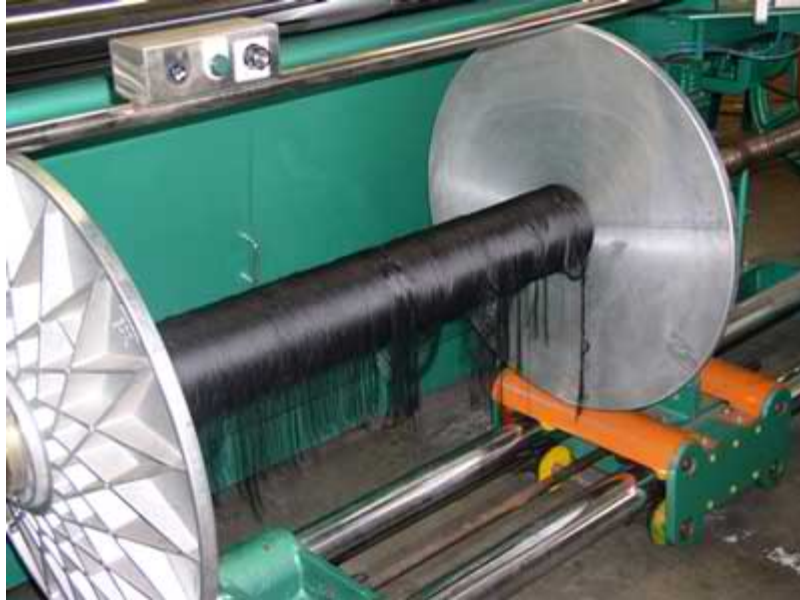
On the day of the incident, the victim was operating the warper machine, and a video surveillance camera in the shop showed that the victim placed his hands in the proximity of the spool while it was spinning. The victim hit the safety bar in front of the machine as he was being pulled into the spool. That action shut the machine down but not before the victim was wound tightly around the spool by the threads. The incident was not witnessed, and the time lapse before the victim was discovered was seven minutes. The company president discovered the victim and tried to rescue him by cutting the threads. The paramedics subsequently arrived and checked the victim for vital signs. They found no pulse or respiration and pronounced him dead.

Exhibit 4. A picture of the spool of thread the victim was caught in.

Recommendation #1: Ensure employee safety by installing guards around the moving parts and pinch points of the machine to protect employees from accidental contact.

Discussion: In this particular case, the victim was seen reaching into the machine while the spool of thread was spinning at a high rate of speed. Because of the ever-present danger of entanglement when working near moving machinery parts, employers should continually strive to protect employees by providing machine guarding in the areas where work is actually performed upon the material being processed. Swivel double-bar gates would be one method of providing this protection. Employers

should contact machine manufacturers and, if applicable, retrofit the machine with guards which will prevent any part of the body from contacting the machines moving parts. Electronic sensors can also be used to protect employees from moving parts and pinch points, as they shut down the machine whenever the sensor beam is broken.

Recommendation #5: In addition, manufacturers should consider designing and installing an emergency brake system in conjunction with the emergency stop bar.

Discussion: In this particular case, when the victim was being pulled into the spool of thread, he hit the

safety bar to shut the machine down. However, by the time the machine stopped rotating, the victim was wound tightly in the threads causing his death. A braking system activated by the use of the safety bar would have stopped all motion of the machine instantly, and might prevent future incidents such as this one from occurring.

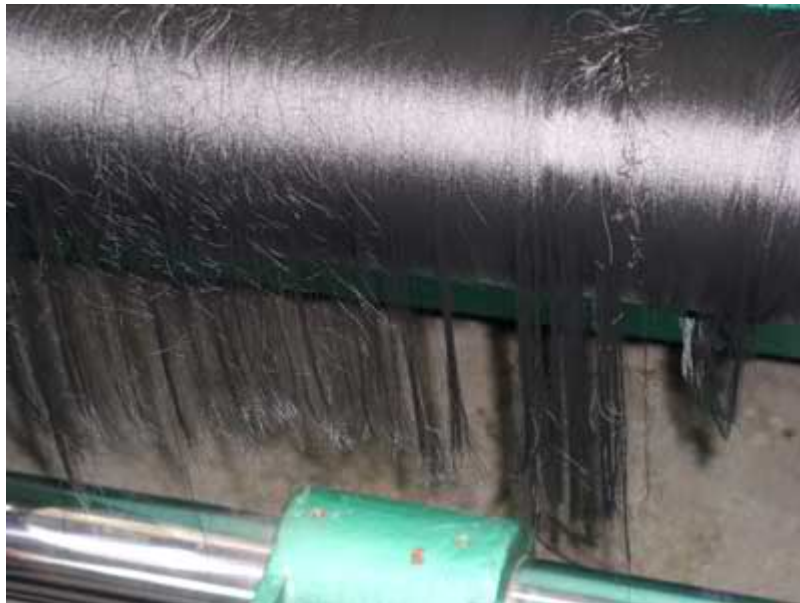
Exhibit 5. A picture of the threads that were being wound on the spool the victim was caught in.

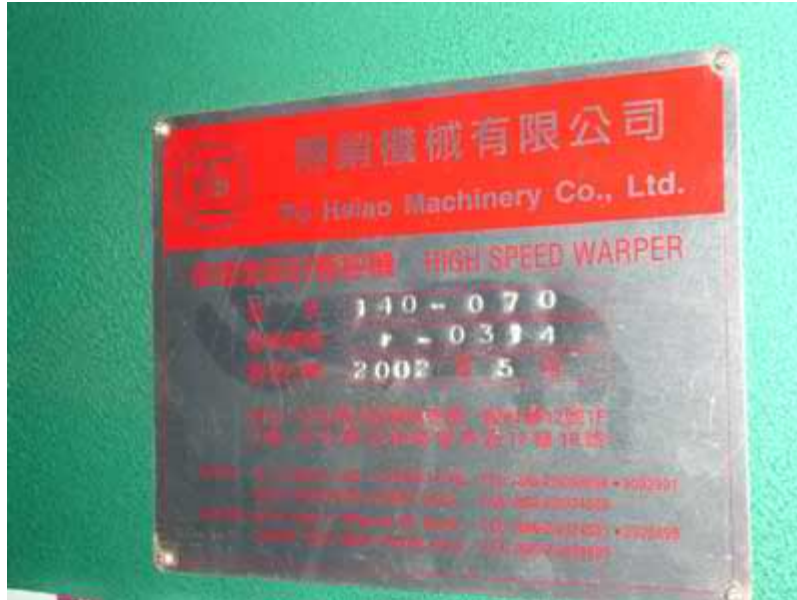
Exhibit 6. A picture of the name plate on the machine involved in the incident.
