Cananea Copper Mine

An International Effort to Improve Hazardous Working Conditions in Mexico

INT J OCCUP ENVIRON HEALTH 2009;15:14-20

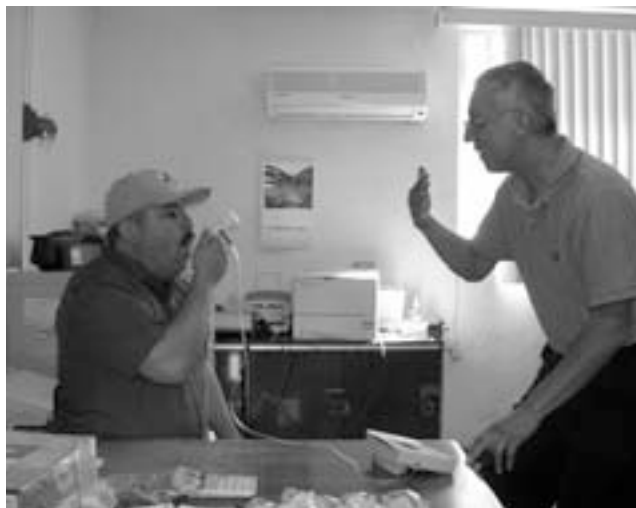
Figure 2—Pulmonology technician Moises Ortega conducts a spirometry test with a copper miner following the industrial hygiene interview.

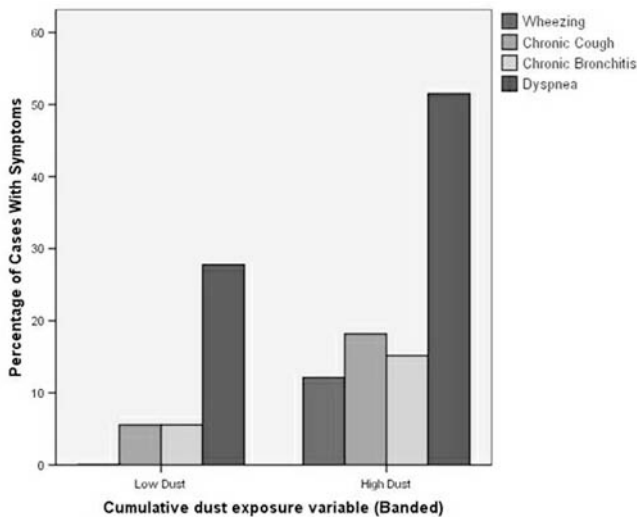
Figure 3—Workers with respiratory symptoms, by dust exposure category.

Figure 3 shows the adverse health effects in the two dust exposure categories. The symptoms appear to be related to dust exposure estimates; however, they likely underestimate the burden of disease that will occur in this population if exposures were to continue at the same level after re-opening of the plant.⁷⁻⁹

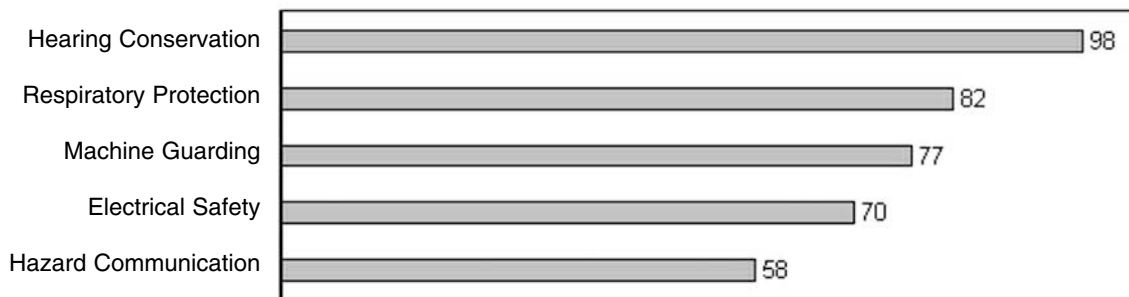
Training and Monitoring. Based on interviews, workers who were exposed to regulated hazards (chemical, noise, and electrical hazards) or utilized mandated safety procedures (lockout/tagout procedures, use of respirator) have not received the safety training required by Mexican regulations. Figure 4 shows the percentage of workers reporting that they have never received health and safety training on regulated hazards and procedures.

Figure 4—Percent of workers reporting no training, by topic of concern.
